DEPARTMENT OF TRANSPORTATION

Contract #: 04-0120F4Cty: SF/ALA Rte: 80 PM: 13.2/13.9File #: 1x.28**WELDING INSPECTION REPORT****Resident Engineer:** Pursell, Gary**Address:** 333 Burma Road**City:** Oakland, CA 94607**Report No:** WIR-014688**Date Inspected:** 08-Jun-2010**Project Name:** SAS Superstructure**OSM Arrival Time:** 700**Prime Contractor:** American Bridge/Fluor Enterprises, a JV**OSM Departure Time:** 1100**Contractor:** American Bridge/Fluor Enterprises, a JV**Location:** Job Site

Bridge No: 34-0006**Component:** OBG Sections**Summary of Items Observed:**

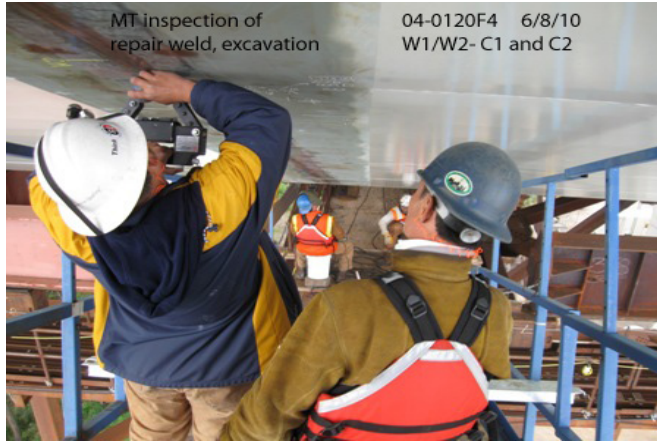
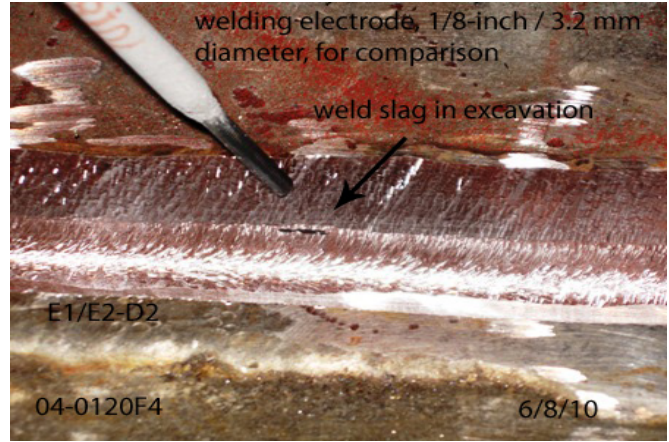
At weld joint E1/E2 – D1 and D2, outside the OBG section this QA Inspector observed ABF welding personnel

Mitch Sittinger (#0315) performing repair welding using the SMAW process. This QA Inspector observed QC Inspector Bonifacio Daquinag Jr. was present and monitoring the welding. This QA Inspector performed a verification of the welding parameters and observed the following: 132 amperes using a 2.4 mm E7018 electrode in the overhead (4G) position. The welding observed appeared to be in accordance with Welding Procedure Specification (WPS) ABF-WPS-D15-1001-Repair.

At weld joint E1/E2 – D1 and D2, inside the OBG section this QA Inspector observed ABF welding personnel Fred Kaddu (#2188) using a grinder to excavate an area rejected by QC during the Ultrasonic Testing (UT) of the weld. This QA Inspector observed QC Inspector Jesse Cayabyab perform a visual and Magnetic Particle Testing (MT) on the excavation. QC Inspector Jesse Cayabyab informed both ABF welding personnel Fred Kaddu (#2188) and this QA Inspector the area needed additional grinding to remove welding slag. Please see photo below. ABF welding personnel Fred Kaddu (#2188) resumed grinding the excavation area. This QA Inspector observed QC Inspector Jesse Cayabyab perform a visual and MT on the excavation. QC Inspector Jesse Cayabyab informed both ABF welding personnel Fred Kaddu (#2188) and this QA Inspector the defect appeared to have been removed. This QA Inspector performed a random visual verification and observed the excavation was approximately 290 mm long, 25 mm wide and 19 mm deep. The excavation was located at “D2” between the 6th and 7th stiffener from the “E” plate. This QA Inspector observed ABF welding personnel Fred Kaddu (#2188) preheat the weld repair area and start the SMAW to complete the repair weld. Prior to welding this QA Inspector QC Inspector Jesse Cayabyab verify the following welding parameters: 140 amperes using a 3.2 mm E7018 electrode in the flat (1G) position. The preparation of the excavation and welding observed appeared to be in accordance with Welding Procedure Specification (WPS) ABF-WPS-D15-1001-Repair.

At weld joint W1/W2- C1 and C2, outside the OBG section, this QA Inspector observed ABF welding personnel Chun Fai Tsui (#3426) performing SMAW welding on an excavation located at the “C2” section of the weld and ABF welding personnel James Zhen (#6001) excavating and area located at the “C1” section of the weld. This QA Inspector observed QC Inspector Bonifacio Daquinag Jr. present and monitoring the work. This QA Inspector performed a verification of the welding parameters being used by ABF welding personnel Chun Fai Tsui (#3426) and observed the following: 125 amperes using a 3.2 mm E7018 electrode in the overhead (4G) position. This QA Inspector randomly observed as ABF welding personnel James Zhen (#6001) proceeded with grinding to excavate the repair area. This QA Inspector randomly observed QC Inspector Bonifacio Daquinag Jr. perform a visual and MT inspection of the excavation and informed this QA Inspector the defect appeared to have been removed and was acceptable for welding. Please see photo below. This QA Inspector performed a visual verification of the excavation and observed the excavation was approximately 470 mm long, 20 mm wide, 16 mm deep and started 2, 220 mm from the “B” plate of the OBG. The preparation of the excavation and welding observed appeared to be in accordance with Welding Procedure Specification (WPS) ABF-WPS-D15-1001-Repair.
